CONTENTS

Introduction	11
Project Background	11
ABOUT ASWP	11
Clean Water Act	11
Impairments to Buffalo Creek	12
Project Goals	12
Public Engagement and Outreach for WIP Development	13
Cornplanter Run - Buffalo Creek (HUC-12)	17
HUC-12 Watershed Context	17
HUC-12 WATERSHED CHARACTERISTICS	18
HUC-12 WATERSHED ANALYSIS	25
Selection of Target Subwatersheds	32
Water Quality Sampling and Testing	33
Green Acres Road Subwatershed	36
Watershed Characteristics	36
Watershed Analysis	45
Implementation Plan, Green Acres Road Subwatershed	50
Worthington Subwatershed	58
Watershed Characteristics	58
Watershed Analysis	67
Implementation Plan, Worthington Subwatershed	74

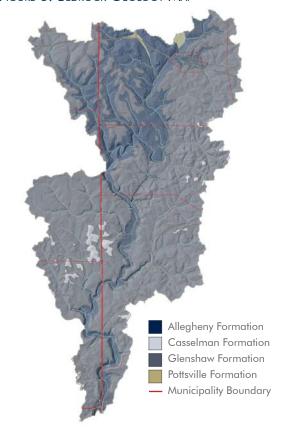
FIGURE 6: BEDROCK GEOLOGY MAP

The Allegheny Formation, typically associated with coalbearing strata, is shown in dark blue, suggesting the presence of coal seams which could impact land use and water quality due to the potential for mining activities and related pollutants. The Casselman Formation, in lighter blue, indicates areas where sedimentary rocks such as sandstone, shale, siltstone, and coal may be found, influencing soil permeability and erosion patterns.

In essence, these geological maps serve as a baseline for assessing the watershed's capacity for supporting wildlife, forestry, agriculture, and human settlement, as well as for anticipating challenges such as acid mine drainage or sedimentation. They provide a foundational understanding that is crucial for the design and implementation of conservation strategies and for predicting the responses of the watershed to various land use and climate scenarios.

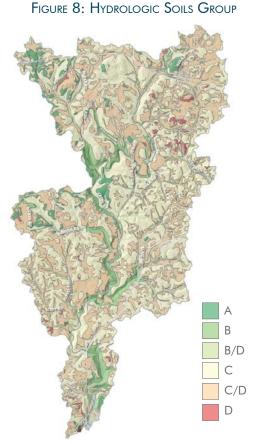
Figure 8 presents the hydrologic soil groups of the Cornplanter Run - Buffalo Creek, offering crucial insights into the watershed's soil composition and its capacity to support infiltration and runoff. The hydrologic soil groups, designated from A to D, are categorized based on their infiltration rates when thoroughly wet.

Soil group A, represented in dark green, indicates soils with high infiltration rates even when thoroughly wet and a low runoff potential. These soils are typically well-drained sands, loamy sands, or sandy loams. Their presence is crucial for groundwater recharge and reducing surface runoff, making them optimal for supporting healthy aquatic ecosystems and mitigating flood risks.

Soil group B, shown in lighter green, has a moderate infiltration rate when thoroughly wet and consists mainly of silt loams or loams. These soils are more fine-textured than group A and are less permeable, offering moderate drainage and supporting diverse agricultural needs while still providing sufficient water filtration.

The B/D designation is an intermediary, demonstrating transitional areas where soil properties may vary, affecting their drainage and runoff behaviors and influencing sitespecific management practices.

Soil group C, colored in beige, encompasses soils with slow infiltration rates when wet and a moderately high runoff potential, often including clay loams, sandy clays, and silty clays. These soils can pose challenges for water management due to their higher potential for flooding and erosion, necessitating strategic planning to manage excess surface water effectively.

Soil group D, the least permeable, depicted in red, has very slow infiltration rates and a high runoff potential. These clayey soils are often associated with poor drainage and are commonly found in areas with high water tables. Their management is critical as they are prone to producing a lot of surface runoff, which can carry pollutants into the watershed and require robust stormwater management systems.

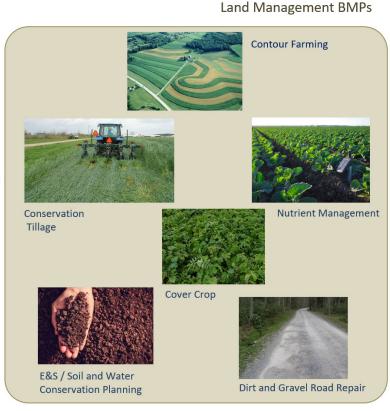
FIGURE 14: LAND MANAGEMENT AND CONVERSION BEST MANAGEMENT PRACTICES

Based on ModelMyWatershed guidance and generally accepted practices in watershed, agricultural lands, and stormwater management, a number of BMPs were explored for this WIP effort. These are summarized below:

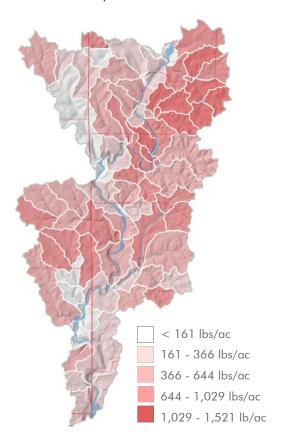
FIGURE 17:
TOTAL SEDIMENT, POLLUTANT CONCENTRATION

Sediment pollution in streams is indicative of the presence of soil, algae, organic remains, and other particulate matter. Elevated sediment levels are known to compromise water clarity, disrupt photosynthesis, and degrade habitats. The map's red zones suggest critical areas where land-based activities, such as agriculture, urban development, and natural erosion, that are contributing to sediment influx. These regions warrant immediate attention to mitigate the detrimental effects on water quality.

Geographically, the hotspots exhibit a discernible pattern, often clustered along steep terrain, agricultural peripheries, and urban runoff pathways. These areas are likely to be significant sediment sources, propelled by soil disturbance and inadequate vegetative cover. Stream bank erosion and the absence of riparian buffers further accentuate the sediment levels, as evidenced by the dense clusters of red along the watercourses.

Urban areas with impervious surfaces exacerbate the issue by funneling stormwater, laden with particulates, directly into the creek system. The confluence of tributaries appears to be a common site for hotspots, where sediment from various sources aggregates due to merging flows.

The implications of these data are significant, affecting not only the health of the watershed's ecosystems but also bearing on human interests such as water treatment, recreation, and property values. Thus, the sediment map is more than a diagnostic tool; it is a foundation for informed action, shaping the efforts of policymakers, conservationists, and community stakeholders in their collective endeavor to safeguard the Cornplanter Run - Buffalo Creek watershed.

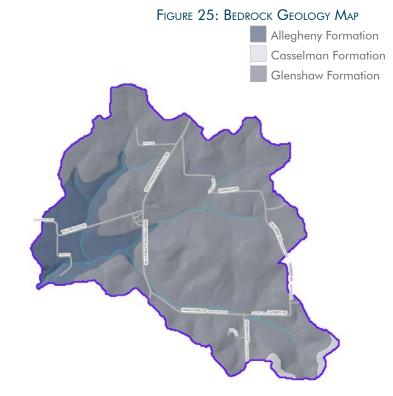
Near the mouth and depicted in the figure to the right in dark blue, the bedrock geology is of the Allegheny Formation. The primary lithology of the Allegheny Formation is sandstone, as shown in the figure to the right by the steel blue region. In general, we see this sandstone lithology follow the main stem and major tributaries up and down the entirely of the Buffalo Creek watershed. Sandstone is formed from the cementation of sand particles. In a fluvial environment, the flow along main stem likely acted as a major depositional area for these particles, leading to the formation of sandstone specifically along the stream's course. Secondary and

tertiary lithologies within the Allegheny Formation include shale, limestone, clay and coal. These factors include both the suitability of the lands for agricultural use and the drainage characteristics overall.

Higher up in the subwatershed, the Glenshaw Formation (dark gray) becomes the dominant bedrock geology, and a small portion of the subwatershed is of the Casselman Formation (light gray in Figure 25). Both have a primary lithology of shale, depicted as blue-green in Figure 26. The secondary and tertiary lithologies of the Glenshaw Formation are sandstone, limestone and coal. They are siltstone, sandstone, limestone and coal for the Casselman Formation.

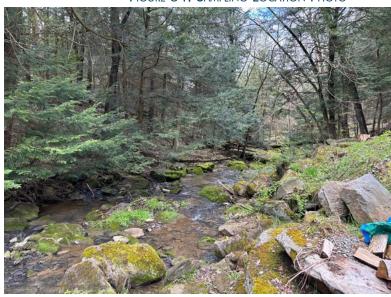
FIGURE 34: SAMPLING LOCATION PHOTO

Although the taxa richness at Oikos-3 is satisfactory at 22, and the EPT richness is relatively high at 13, these results may not accurately reflect the conditions throughout the Green Acres Road subwatershed. Due to difficulty with sampling access in a more representative location, the sampling site is under significant tree cover and well connected to the diverse main stem of Buffalo Creek, which likely contributes to the higher water quality and macroinvertebrate diversity observed.

Given the changes in land cover and stream channel morphology upstream, the positive indicators such as a lower Hilsenhoff biotic index of 3.76, a Shannon diversity index of 2.04, and an IBI score of 66.00 may not represent the subwatershed's overall health. The results likely represent the buffered conditions near the mouth of Buffalo Creek rather than the impacted upstream areas on private land where sampling could not be conducted.

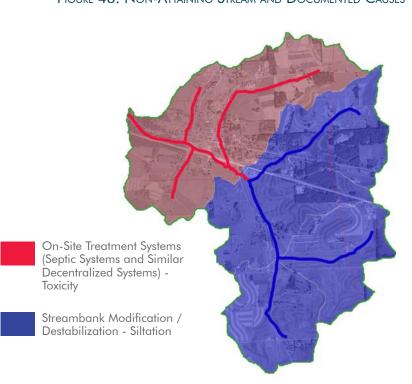
FIGURE 48: NON-ATTAINING STREAM AND DOCUMENTED CAUSES

The blue area shown on Figure 48 denotes regions where streambank modification and destabilization has led to siltation to the stream - a process where eroded soil deposits reduce water clarity and quality, affecting aquatic habitats. This informed the WIP's emphasis on streambank stabilization efforts, such as the introduction of vegetation and structural supports to prevent further erosion and siltation, which are essential for the health of aquatic ecosystems and the clarity of water channels.

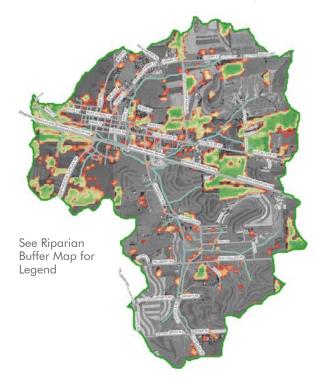
The tree canopy map (Figure 49) indicates the distribution of wooded areas within the subwatershed. These areas are critical for reducing stormwater runoff, minimizing erosion, and filtering pollutants before they enter the water system. The patches of green signal where these benefits are actively at work. However, the map also reveals significant gaps in the canopy, particularly in areas that are more developed or used for agriculture. These gaps suggest potential areas where restoration efforts should focus on increasing tree cover to enhance the subwatershed's ecological services and resilience.

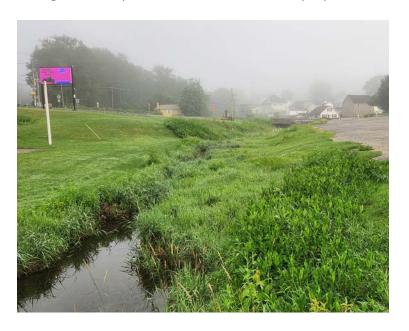
Additional riparian buffer opportunities exist within the Borough of Worthington. Priority should be given to areas where paved or gravel areas drain directly to the stream, with limited vegetation to filter. The image below is a good example of a suitable restoration project area.

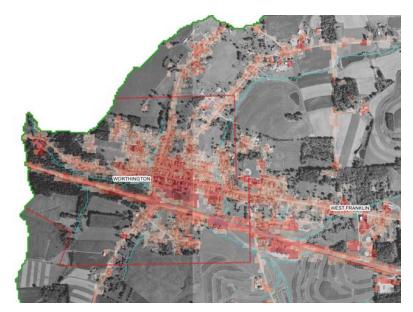
FIGURE 60: IMPERVIOUS SURFACE COVERAGE, WORTHINGTON BOROUGH

The urban landscape within and around the Borough of Worthington presents both challenges and opportunities for improving water quality in the Worthington subwatershed. The high levels of impervious surfaces, as shown in Figure 59, are indicative of urban development that can significantly alter hydrologic processes, leading to increased runoff, reduced infiltration, and heightened potential for pollutant transport into the stream system.

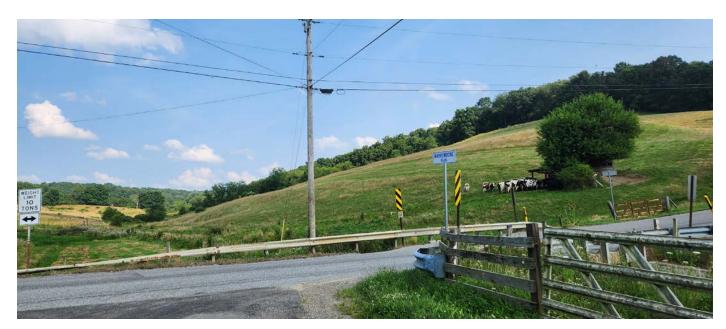
FIGURE 80: HEAVY USE GRAZING WITH VISIBLE STREAM IMPACTS

Based on NLCD land cover data, there are approximately 23 acres of critically or severely degraded riparian buffer areas within mapped hay / pasture land throughout the Marrowbone Run subwatershed. Based on site observations and an assessment of aerial imagery, much of this area is active grazing land that has a high potential impact on stream health and pollutant load, with little or no provisions for exclusionary fencing.

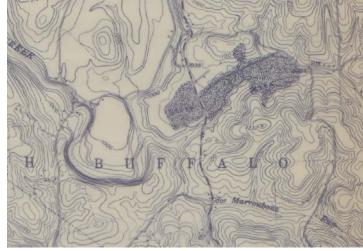
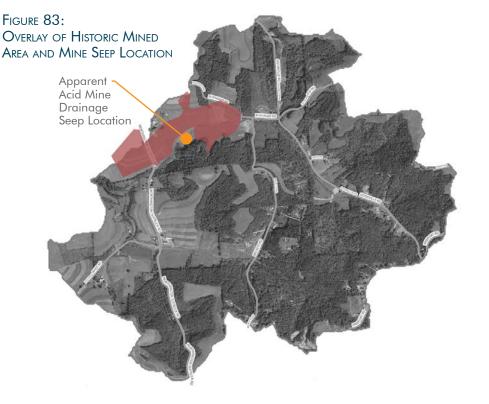
FIGURE 81 (TOP) AND
FIGURE 82 (BOTTOM):
HISTORIC STRIP MINE AREA
WITHIN THE MARROWBONE RUN
SUBWATERSHED

Figure 81, sourced from the USGS 1958 via the Pennsylvania Mine Map Atlas, provides a detailed topographic view of the terrain before or during the mining activities. The intricate contour lines and shaded areas indicate the excavation and deposition areas associated with strip mining. A much later report (Figure 82) from September 2000, titled "Assessment of Nonpoint Source Pollution for the Buffalo Creek Watershed in Southwest Pennsylvania" and prepared by the Armstrong Conservation District, identified the "Old Stripmine Discharge", suitable for wetland or passive treatment system.

Although no documentation was found of any AMD remediation installation related to this site, an aerial assessment of imagery from 2021 indicates an interesting drainage feature in this same location. Active drainage in this location is clearly visible in aerial imagery (right) from 1993 and likely predates this period. If this is the historic stripmine discharge point referenced in the 2000 report, it is recommended that this be further investigated as part of the future remediation efforts. If it was previously remediated with a passive treatment system, additional water quality testing could be used to assess its effectiveness and any need for system maintenance or restoration. If the seep has not been previously remediated, then activities

The 2008 Buffalo Creek Watershed Conservation Plan 10-Year Update indicated that this drainage is alkaline, containing iron from strip mines. It also indicates that the discharge has "severely impacted Marrowbone Run". This suggests that this discharge point should be monitored and potentially addressed going forward as part of the WIP.

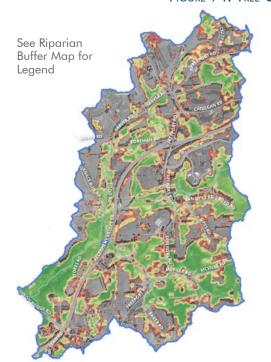
FIGURE 94: TREE CANOPY MAP

The tree canopy map (Figure 94) and riparian buffer map (Figure 95) of Pine Run subwatershed depict significant ecological disturbances that have implications for watershed health and management.

Figure 94 shows substantial disruption of healthy tree canopy, particularly around high development zones like RIDC Armstrong Innovation Park. The fragmentation of the canopy due to industrial expansion has likely altered local microclimates and reduced the habitat quality for wildlife. It also has potential implications for air

quality and carbon sequestration capabilities within the region. The preservation of existing canopy and reforestation efforts in deforested areas is critical to restore ecological balance and enhance the region's natural resilience.

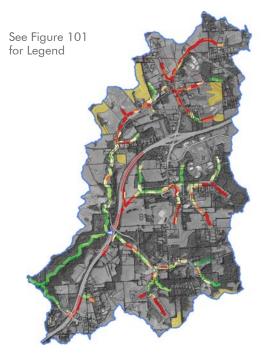
Figure 103: Prioritizing Riparian Buffers
Based on Upstream Best Management Practices

Figure 103 overlays the riparian buffers within the Pine Run subwatershed with existing contour farming practices. In this case, the restoration strategy would be to prioritize buffer restorations in areas not already protected by existing BMPs. As this map illustrates, contour farming is not a common practice in the Pine Run subwatershed, and so there are fewer places where existing depleted riparian buffers are already somewhat protected by agricultural BMPs. This is an opportunity for future restoration efforts. Riparian buffers are also largely missing along major highways;

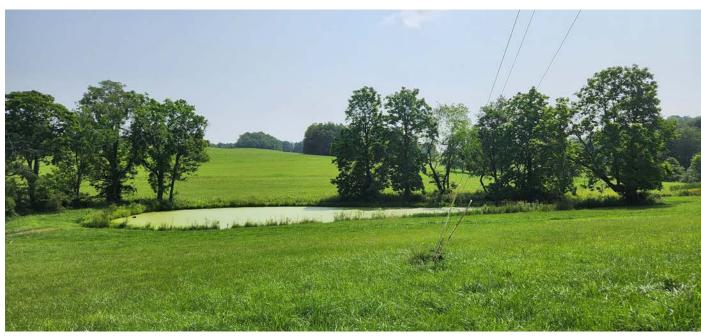
Based on site observations, it appears that the ponds (Figure 105, aerial) were likely designed under older stormwater regulations FIGURE 105: IMPERVIOUS AREA COVERAGE AT RIDC ARMSTRONG INNOVATION PARK AND AERIAL IMAGERY

Figure 105 illustrates the density and distribution of impervious surface cover in and around the RIDC Armstrong Innovation Park - formerly known as RIDC Northpointe Industrial Park - and in immediately adjacent areas. As indicated in the heatmap and aerial imagery, the extensive impervious surfaces, such as large parking expanses and the ongoing development pressures, pose significant challenges for watershed management.

which lack the current emphasis on volume control and water quality. No volume or water quality control BMPs were observed at the site. Rather, the existing stormwater management systems consists of large, centralized wet ponds and are presented in RIDC marketing literature as "integrated" and ready for connection for new tenant. This language suggests that any new development would possibly be grandfathered into the previously approved stormwater management controls and would not necessarily be subject to further review by the municipality or the Conservation District under the National Pollution Discharge and Elimination Systems (NPDES) permit, except perhaps on a superficial level to confirm previous calculations. This presents a significant hurdle for meeting and maintaining water quality standards, as these pre-established systems do not well align with contemporary environmental goals.

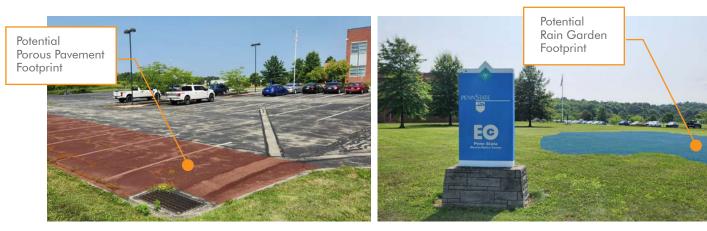
Figure 106: Ideas for Incorporating Green Infrastructure into RIDC Armstrong Innovation Park

be grant funded or constructed as part of an agency partnership, assuming that the burden would not be on private developers grandfathered into the existing facilities. Such strategies may include the targeted addition of green infrastructure elements, combined with selective naturalization of manicured lawn areas to soften the developed nature of the site overall. The challenge lies in balancing the park's growth with the health of the Pine Run subwatershed, ensuring that economic and industrial progress does not come at the cost of ecological integrity.

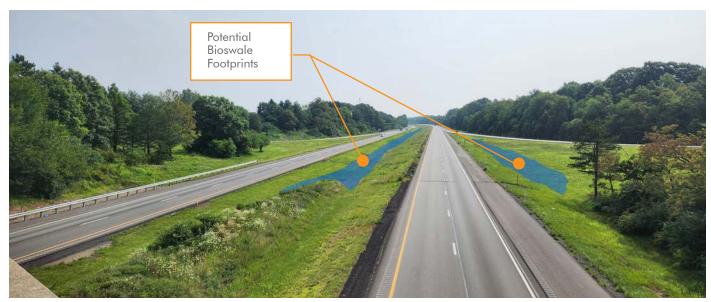
FIGURE 108: HIGHWAY BIOSWALE DESIGN CONCEPT

In the Pine Run subwatershed, the Allegheny Valley Expressway, managed by PennDOT, presents unique opportunities for partnership in the context of watershed restoration. As shown in Figures 107 and 108, the natural and constructed drainage way courses through the median in portions of the expressway - a tangible intersection of infrastructure and watershed health.

In addition, the partnership could explore retrofitting existing drainage systems to incorporate advanced filtration systems, ensuring that runoff from the roadway is treated before it enters Pine Run. PennDOT's maintenance practices could also be aligned with conservation goals, including the use of native plantings in landscaping to promote biodiversity and reduce maintenance needs.

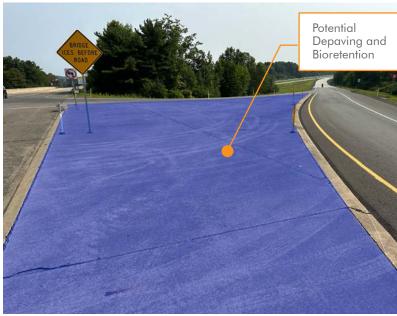
FIGURE 109: HIGHWAY DEPAVING AND BIORETENTION DESIGN CONCEPT

One potential focus area is the optimization of existing stockpile sites adjacent to the Allegheny Valley Expressway. Enhancements could be made to the current stormwater management systems, including creating vegetated swales or bioretention areas around these sites to filter runoff before it reaches the

The existing Park-and-Ride near the RIDC Armstrong Innovation Park also presents an opportunity for retrofitting with green infrastructure (Figures 109 and 110). Improvements could involve the installation of rain gardens, bioswales, and filtering measures to manage stormwater effectively. These upgrades would not only mitigate surface runoff but also contribute to the reduction of non-point source pollution, a key aspect of PennDOT's MS4 (Municipal Separate Storm Sewer System) obligations. MS4 requirements emphasize the need for municipalities, including state agencies, to address stormwater runoff in urbanized areas.

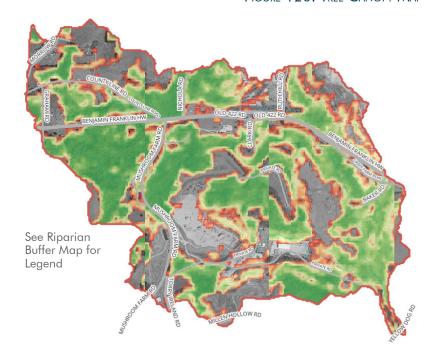
The tree canopy map, with areas of lush green indicating healthy vegetation and stark red areas where the canopy is absent, tells a story of contrast and the need for restoration. These red areas, where riparian buffers are completely depleted, are the

most immediate concern for mitigation efforts. Replanting trees and reestablishing vegetation in these areas would not only help to filter pollutants before they reach waterways but also restore the habitat necessary for local wildlife and help to stabilize the soil, preventing further erosion and runoff issues.

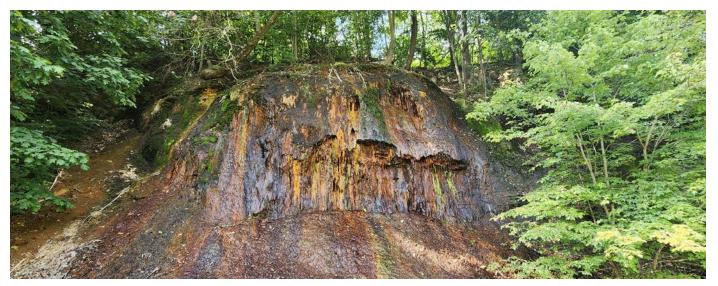
The image below is a significant AMD discharge through the limestone cliffs, located immediately off Craigsville Road, and adjacent to the Benjamin Franklin Highway overpass. Although this discharge point is not within any of the five (5) WIP study areas, it does discharge to the Buffalo Creek main stem only about 600 feet from the mouth of the Worthington subwatershed and about a mile upstream of the Moonlight Drive mouth. Equally significant, it appears to discharge from the same legacy mine system that contributes to the Moonlight Drive subwatershed AMD impairments and necessitated the TMDL on the unnamed tributaries within. Although addressing this legacy impairment as part of this WIP would not help to delist the target streams, it would have an offsetting positive impact to Buffalo Creek, effectively treating a different discharge from the same AMD source. For this reason, and because the available land appears to be both accessible and feasible for siting of a future passive treatment system, it is recommended that 319(h) funding be pursued to support additional sampling and assessment efforts. These efforts will help better characterize the nature and extent of AMD impacts and build the scientific and technical foundation required to pursue implementation funding from other sources. While AMD remediation is not a primary focus of this WIP and is not proposed for immediate 319 implementation funding, it is included here to guide long-term water quality improvement planning in the Moonlight Drive subwatershed.

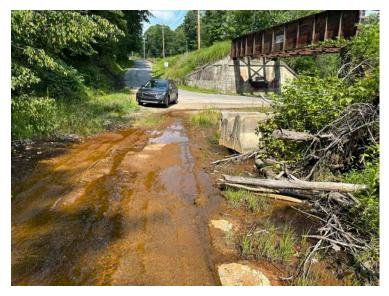
One compelling aspect of this potential AMD remediation site is that it already naturally mimics the first few stages of a conventional passive treatment system - a potential cost savings in any future design efforts. The images to the left below are of the Wingfield Pines AMD treatment system - an

aerial overview and an image of the first treatment stages, aeration and Settling Pond 1. Located along Chartiers Creek in Upper Saint Clair and South Fayette in Allegheny County, the Wingfield Pines site was a former strip mine and golf club. It was acquired by Allegheny Land Trust in 2001, and the constructed AMD treatment and wetland system has been in operations since 2009, treating approximately 1,500 to 2,000 gallons per minute of iron-laden mine discharge.

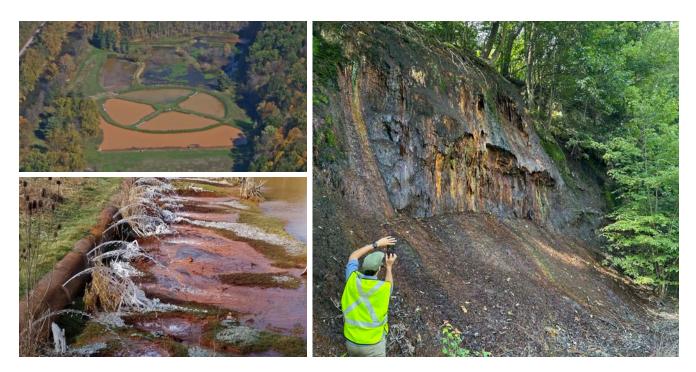
Of particular interest to this WIP are the functional similarities between the first treatment stage of Wingfield Pines and the AMD seep photo shown to the following page. The cascading of iron-rich runoff

down the limestone cliff at the Buffalo Creek site aerates the drainage in much the same way as the perforated distribution pipes at Wingfield Pines do. There is no settling pond at the Buffalo Creek site, of course. However, at the base of the cliff, the pile-up of precipitate is readily visible, collected and impounded in much the same way as the settling ponds would at Wingfield Pines.

In short, there may be an opportunity to build upon the naturally occurring systems at the Buffalo Creek site to further encourage the AMD precipitate to fall out of solution, sequester the precipitate for regular removal, and buffer the acidic discharge through additional treatment and polishing stages prior to discharge into the Buffalo Creek main step a few hundred yards away.

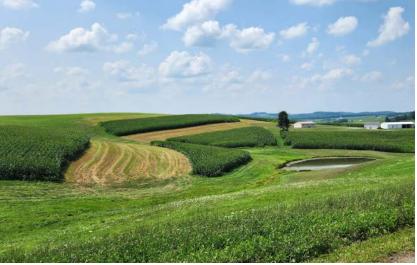
Figure 2: Cornplanter Run Subwatershed

<u>Area:</u> The areas of the two watersheds are nearly identical, with Cornplanter Run covering 1.92 square miles and Green Acres 1.91 square miles. This close match in size ensures that hydrological and land use patterns observed in Cornplanter Run can be scaled appropriately for Green Acres.

<u>Physiographic Context:</u> Both watersheds are situated within the Appalachian Plateau, specifically in the Pittsburgh Low Plateau section. This ensures that any geological or topographical recommendations derived from Cornplanter Run are directly applicable to Green Acres.

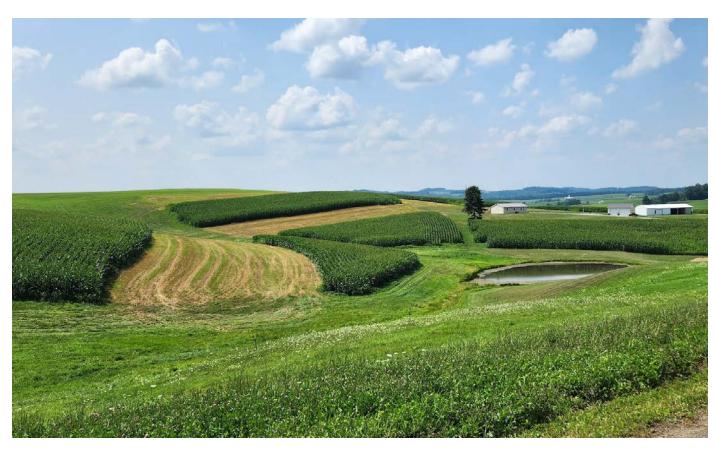
Cornplanter Run Subwatershed

Sources	Sediment (lb)	Total Nitrogen (lb)	Total Phosphorus (lb)
Hay/Pasture	70,702.5	220.1	74.9
Cropland	1,422,225.7	5,620.6	1,525.9
Wooded Areas	2,180.7	78.8	5.8
Wetlands	0.0	0.0	0.0
Open Land	1,022.2	10.7	1.1
Barren Areas	1.6	0.5	0.0
Low-Density Mixed	304.5	7.5	0.8
Medium- Density Mixed	541.9	10.1	1.0
High-Density Mixed	70.7	1.3	0.1
Low-Density Open Space	1,276.3	31.6	3.4
Farm Animals	0.0	398.2	101.0
Stream Bank Erosion	59,291.2	39.7	13.2
Subsurface Flow	0.0	2,286.7	101.7
Point Sources	0.0	0.0	0.0
Septic Systems	0.0	17.8	0.0

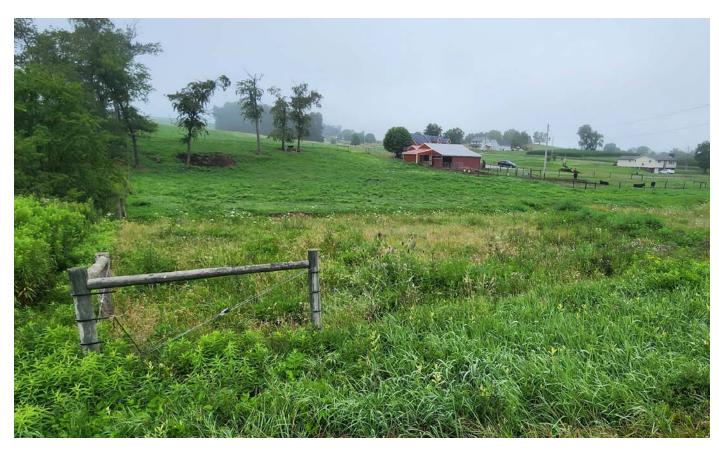
CORNPLANTER RUN

Sources \$	Sediment (lb)	Total Nitrogen (lb)	Total Phosphorus (lb)
Hay/Pasture	70,702.5	220.1	74.9
Cropland	1,422,225.7	5,620.6	1,525.9
Wooded Areas	2,180.7	78.8	5.8
Wetlands	0.0	0.0	0.0
Open Land	1,022.2	10.7	1.1
Barren Areas	1.6	0.5	0.0
Low-Density Mixed	304.5	7.5	0.8
Medium- Density Mixed	541.9	10.1	1.0
High-Density Mixed	70.7	1.3	0.1
Low-Density Open Space	1,276.3	31.6	3.4
Farm Animals	0.0	398.2	101.0
Stream Bank Erosion	59,291.2	39.7	13.2
Subsurface Flow	0.0	2,286.7	101.7
Point Sources	0.0	0.0	0.0
Septic Systems	0.0	17.8	0.0

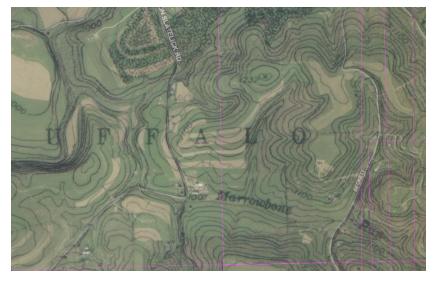
Figure 6: North Branch Rough Run Subwatershed

North Branch Rough Run, encompassing an area of 3.23 square miles, emerged as an ideal reference point. Its similarities with Marrowbone Run in terms of size, slope, and geological characteristics make it a relevant model. North Branch Rough Run is distinguished by its extensive forest cover, which plays a crucial role in filtering pollutants and stabilizing water flow. In terms of water quality, North Branch Rough Run excels, particularly in managing sediment, nitrogen, and phosphorus levels. This underscores the positive impact of well-managed land use.

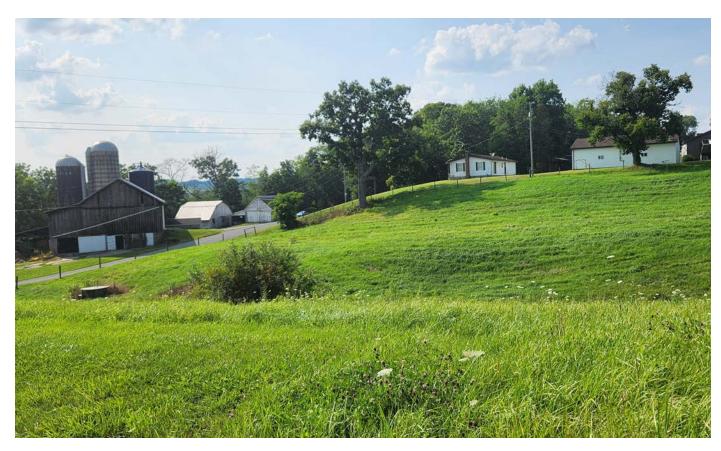
North Branch Rough Run Subwatershed

Sources	Sediment (lb)	Total Nitrogen (lb)	Total Phosphorus (lb)
Hay/Pasture	32,708.8	97.0	35.1
Cropland	573,547.9	2,143.4	585.3
Wooded Areas	3,536.7	26.7	4.0
Wetlands	0.0	0.0	0.0
Open Land	3,080.1	19.2	2.9
Barren Areas	0.9	0.3	0.0
Low-Density Mixed	483.9	12.6	1.3
Medium- Density Mixed	1,112.7	20.3	2.1
High-Density Mixed	107.7	2.0	0.2
Low-Density Open Space	1,137.3	29.6	3.1
Farm Animals	0.0	305.0	79.7
Stream Bank Erosion	49,866.4	28.7	11.0
Subsurface Flow	0.0	2,134.3	86.7
Point Sources	0.0	0.0	0.0
Septic Systems	0.0	49.7	0.0

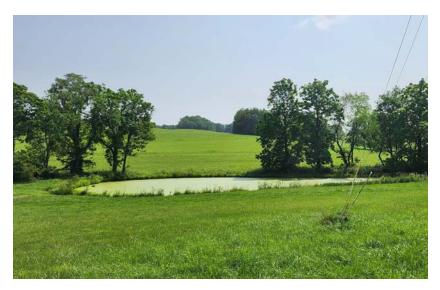
Figure 8: N Branch Rough Run Subwatershed

The North Branch Rough Run, covering an upper region of 4.53 square miles, emerged as an ideal reference. This watershed shares similar characteristics with Pine Run in terms of area, slope, and geology, making it a relevant comparison. Notably, North Branch Rough Run boasts extensive forest cover, which enhances its ability to naturally filter pollutants and manage water flow. In terms of water quality, it excels, particularly in the management of sediment, nitrogen, and phosphorus levels, highlighting the benefits of sound land stewardship.

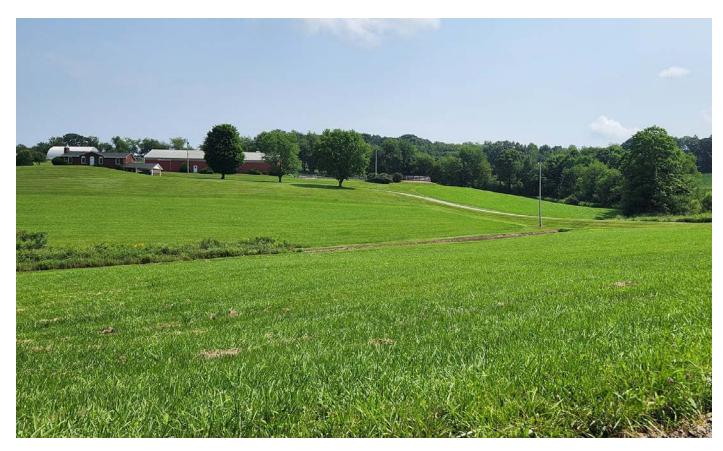
North Branch Rough Run Subwatershed

Sources 💠	Sediment (lb)	Total Nitrogen (lb)	Total Phosphorus (lb)
Hay/Pasture	34,576.1	102.4	37.4
Cropland	886,928.2	3,349.7	914.1
Wooded Areas	4,564.0	35.5	5.2
Wetlands	0.0	0.0	0.0
Open Land	3,659.0	22.2	3.4
Barren Areas	0.9	0.3	0.0
Low-Density Mixed	649.5	16.7	1.8
Medium- Density Mixed	1,347.6	24.5	2.5
High-Density Mixed	129.2	2.4	0.2
Low-Density Open Space	1,746.9	45.0	4.8
Farm Animals	0.0	451.2	117.8
Stream Bank Erosion	85,975.9	48.5	17.6
Subsurface Flow	0.0	2,843.1	124.2
Point Sources	0.0	0.0	0.0
Septic Systems	0.0	56.8	0.0

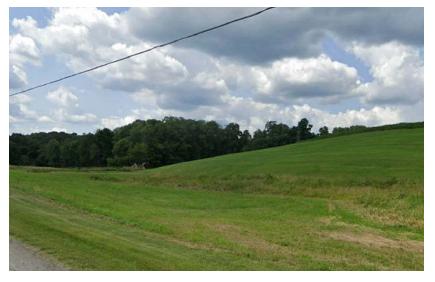
Figure 10: Long Run Subwatershed

In selecting a reference watershed, the goal was to find one that closely resembled Moonlight Drive's topographical and geological nuances but showcased superior land use patterns and water quality indicators. Long Run was identified as a fitting comparison. Its watershed attributes, including area, slope, and geological composition, align closely with those of Moonlight Drive. Long Run's extensive forest cover, which aids in filtering pollutants and regulating water flow, and its commendable water quality, particularly in terms of sediment, nitrogen, and phosphorus levels, highlight the positive impacts of effective land management.

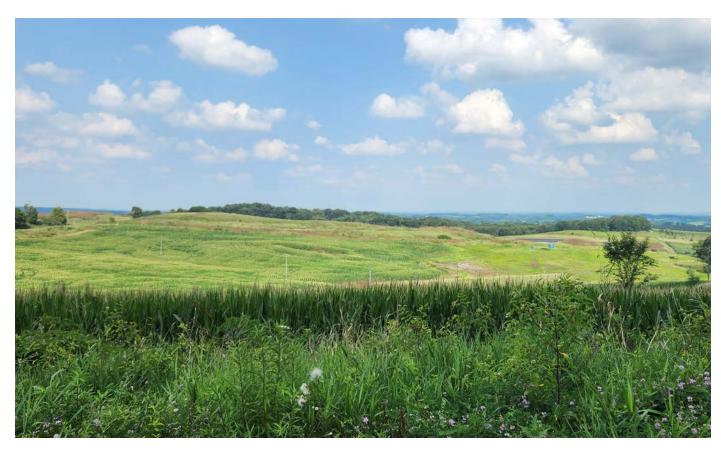
Long Run Subwatershed

Sources	Sediment (lb)	Total Nitrogen (lb)	Total Phosphorus (lb)
Hay/Pasture	85,792.2	246.8	94.8
Cropland	337,994.2	1,206.4	366.5
Wooded Areas	1,805.9	48.0	4.0
Wetlands	0.0	0.0	0.0
Open Land	9,899.7	70.2	10.3
Barren Areas	0.5	0.2	0.0
Low-Density Mixed	184.8	4.6	0.5
Medium- Density Mixed	315.6	6.2	0.6
High-Density Mixed	74.3	1.5	0.1
Low-Density Open Space	645.8	16.2	1.7
Farm Animals	0.0	293.2	70.3
Stream Bank Erosion	23,256.6	13.2	4.4
Subsurface Flow	0.0	1,609.2	65.3
Point Sources	0.0	0.0	0.0
Septic Systems	0.0	14.2	0.0
